SIO Shipyard Representative Bi-Weekly Progress Report		
<b>Project: AGOR 28</b>	<b>Contract No.: N00014-12-C-0305</b>	<b>Shipyard: Dakota Creek Industries</b>
<b>Prepared by:</b> Paul D. Bueren Scripps Institution of Oceanography (SIO) 297 Rosecrans St. San Diego, CA 98106	<b>Date:</b> 23 October 2015	<b>Program Officer:</b> Robert (Tim) Schnoor Office of Naval Research 875 Randolph St ONR 321 Arlington, VA 22203-1995
<b>Distribution Statement A:</b> Approved for public release; distribution unlimited.		<b>Report No. A002.086</b>

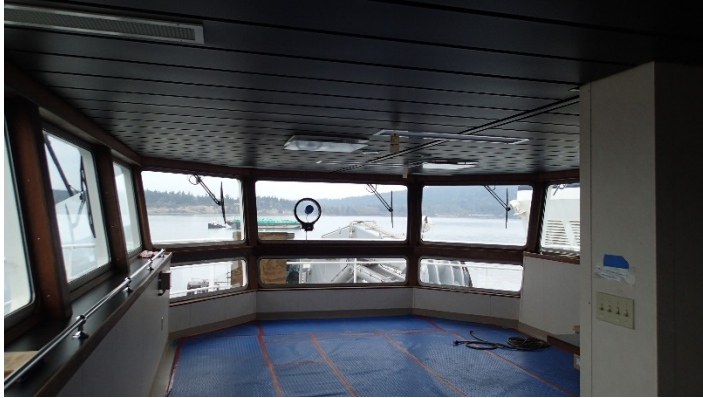
- Hi-PAP - DCI has chosen not to install the HiPAP prior to Phase III.
- Pilot House – The floors are complete. The space is close to 100% complete as far as fit and finish.

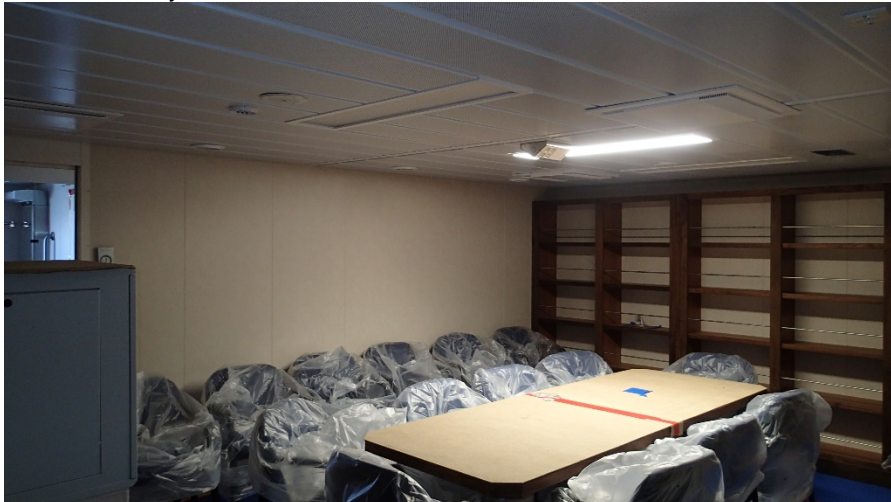
- Accommodation Spaces – DCI continues with the cleaning and prepping of staterooms for close-outs. Tile is being laid in the stair towers. Overheads and furniture have been installed in the Library/Conference Room.

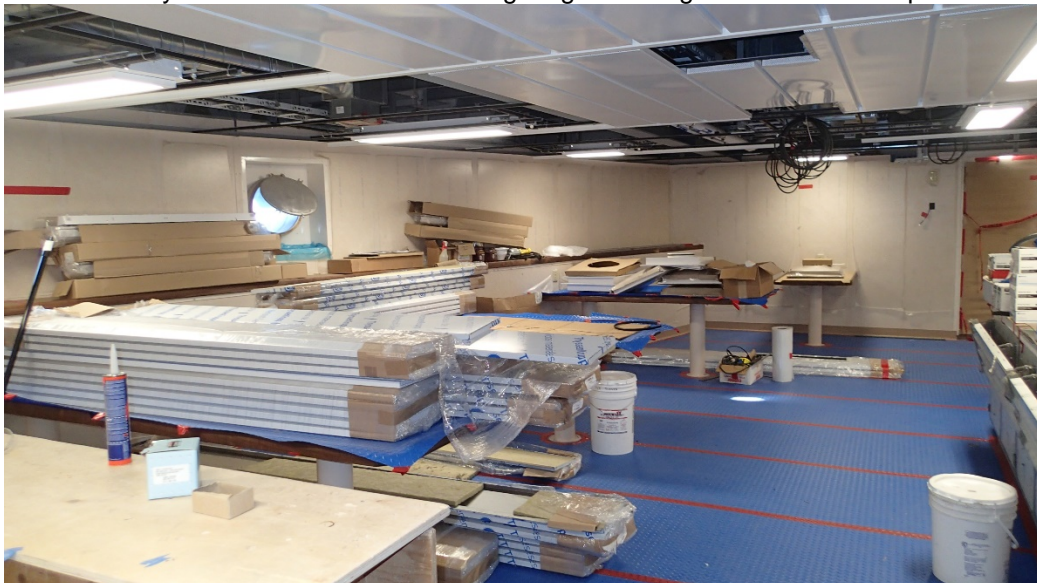
- Galley & Mess – Overheads and lighting are being installed in both spaces.

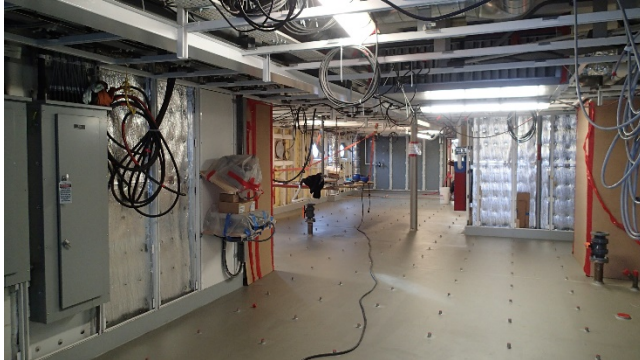
Primed

- Laboratories – The flooring materials are being applied to both the Main and Wet Lab decks.

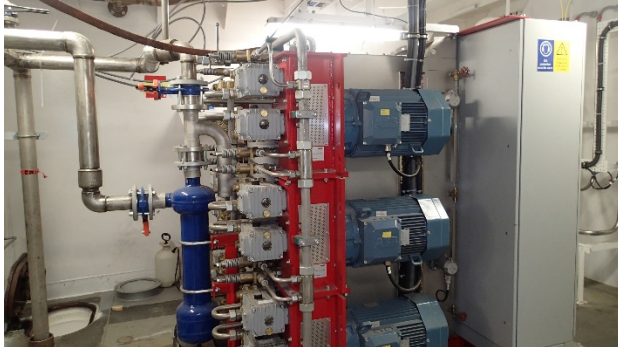
- Deck Machinery – Both the SSHD, CTDHD and Portable Crane were weight tested. The yard was unable to complete the weight tests for both the Stern Frame and Main Crane because both Allied HPU's would not produce the required hydraulic oil pressure needed. The pressure settings for both HPU's have since been corrected by Allied to their specifications. Both the Crane and Stern Frame will be retested.
- Hi-Fog System – The system was commissioned and successfully demonstrated to the USCG, with a couple of minor discrepancies that will be correct when new panel buttons arrive.

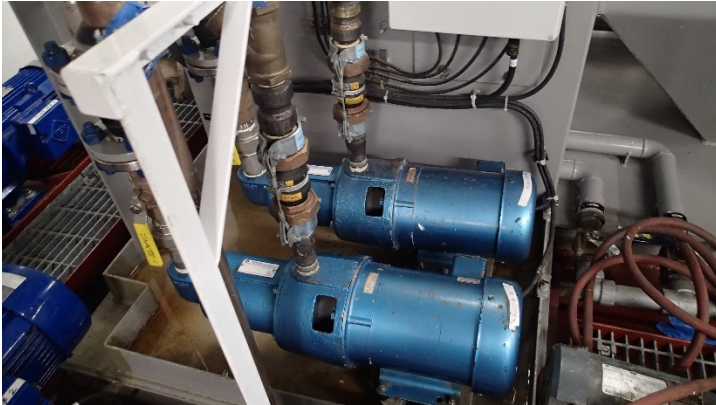
#### MSD Overboard Discharge Pumps

- Red Fox MSD – Tested and Commissioned by vendor. No operational issues, however both overboarding pumps had cracked housings. Vendor suspects factory defect and is replace with new.

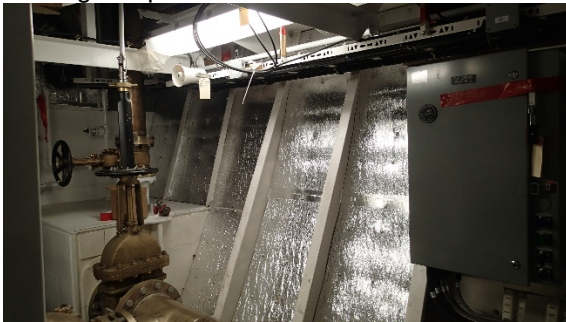
- Sally Ride Quad-Zero MLV – The yard is finishing up the last of the insulation and Quad-zero in the engine space.

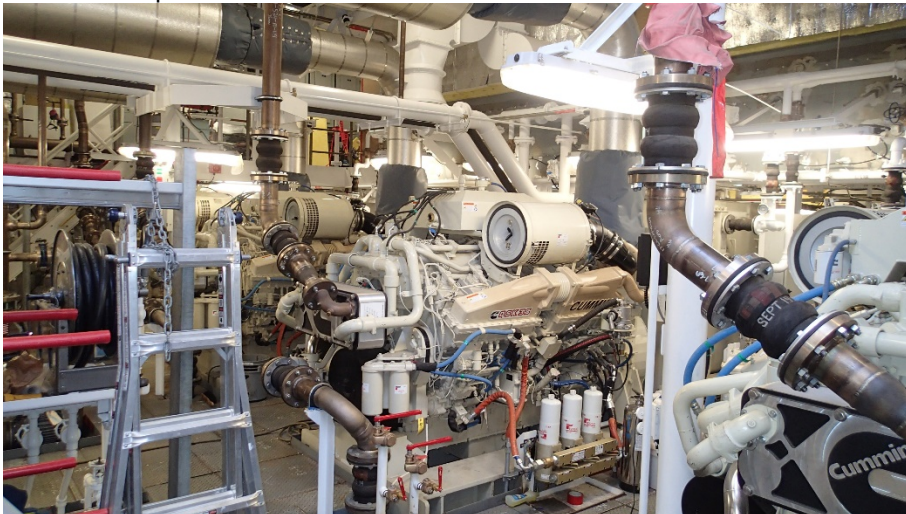
- Main Engine Room – The scaffolding has been removed and the yard is finishing up insulation and painting above the deck plates. Once this is completed, the bilge and deck plating will be cleaned and painted.

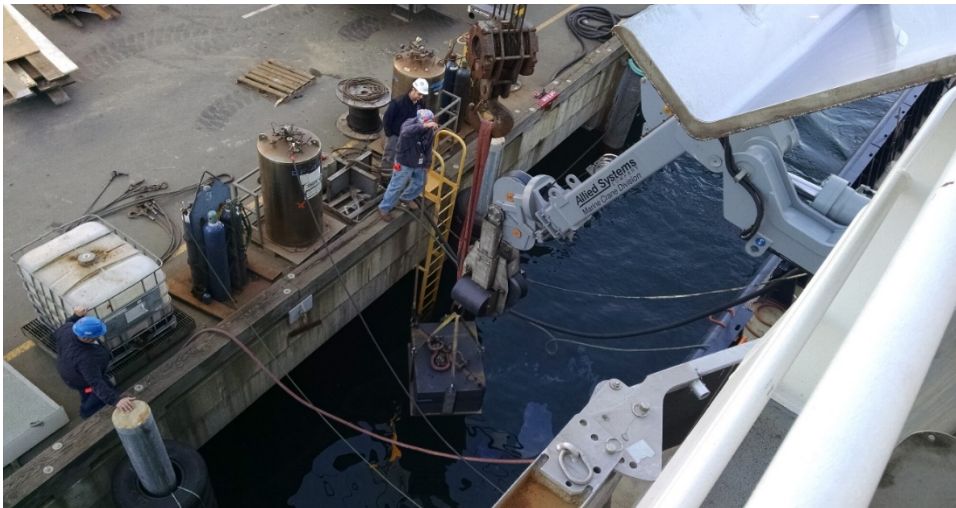
Lots of people and activity this past week. 1<sup>st</sup> Engineer Matt Peers joined the SIO team here in Anacortes. Both CTD handlers and the portable Allied crane weight tests successfully performed.

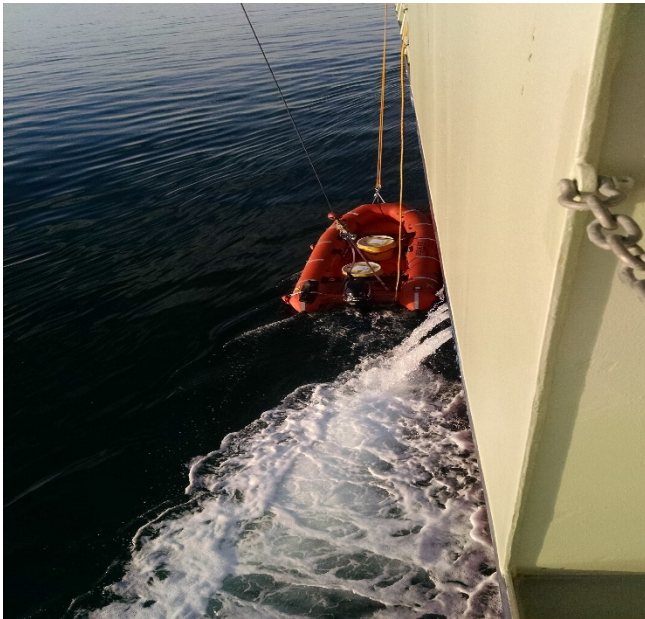
Neil Armstrong got underway to perform emergency drills for Coast Guard. SOLAS rules require rescue boat to be launched while underway. (new one on me) Armstrong's crew did very well on these drills, no

issues. Launched initially with a “simulated” load of two crew members. WHOI used oil spill kit plastic barrels of water for the weight.

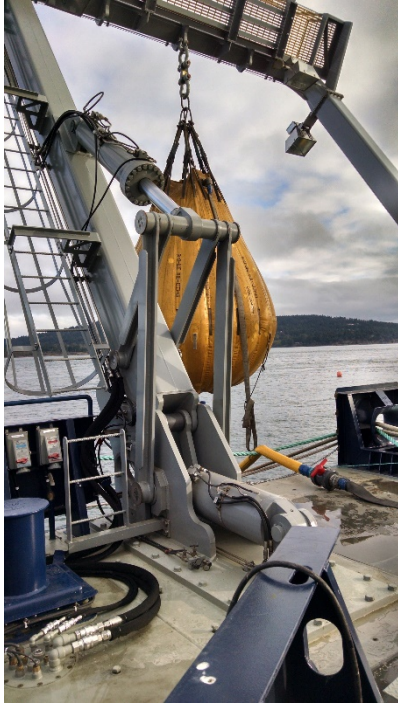
Attempts to weight test A frame unsuccessful. Neither HPU able to achieve necessary pressures to meet the requirements of the test plan. Allied Reps present for test but unable to correct problem. HPU vendor

assistance needed. Allied on it, yard on them. Main crane not tested pending correction of HPU issues.

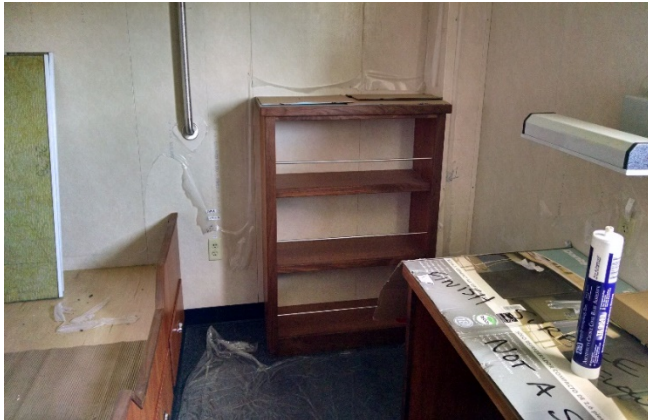
Stowage for personal gear in staterooms seems pretty limited to me. Two under bunk drawers and two lockers. This seems especially true for the double occupancy staterooms. Large bookcases in each room seem unnecessary. Perhaps bookcases can be converted into clothing stowage. Appropriately sized bins to fit the bookshelves may be a possible solution.

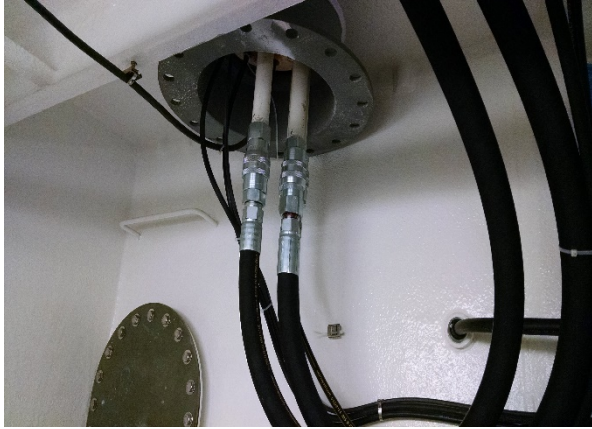
“A” frame control station piping and electrical cables penetrate the deck approximately 3 feet forward of the control station. Assume control station was plumbed this way to keep hoses and wires out of the after peak ballast tank. Yard will provide a metal guard over the hoses but still represents a compromise on fantail utilization. Request we investigate routing hoses and cables through the top of

the after peak tank to operators position. Believe the reduction in clutter on the fantail will be worth it.

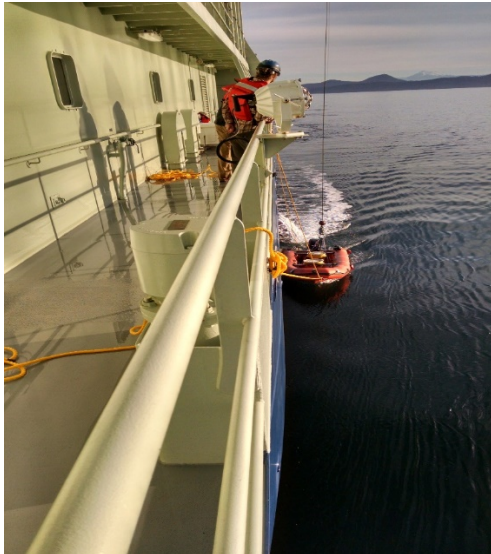
No connection point provided for Rescue Boat Sea Painter, no bitts or cleats provided mid-ships. Armstrong mounted small cleat to fuel tank vent for RB. Sufficient for this drill but not for long term.
